# HOME INSPECTION REPORT

**REAL SPECT**  
HOME INSPECTIONS

1234 School House Road  
Yourtown, US 12345

Prepared for: Bob Smith

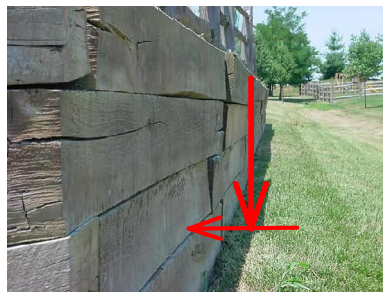
Retaining Walls: Railroad ties / The wall is showing signs of movement, but appears to be stable at this time. A qualified contractor is recommended to evaluate and estimate repairs to maintain the wall.

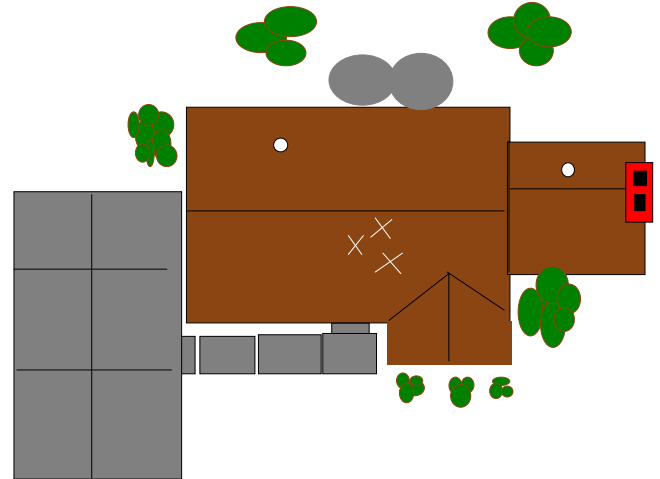
- Method of Inspection: On the roof
- Not Inspected Unable to Inspect: 30% / Height of the roof
- Defective Material: Fiberglass shingle / Missing roof shingles from wind damage as marked "x" in diagram. Repairs are required.

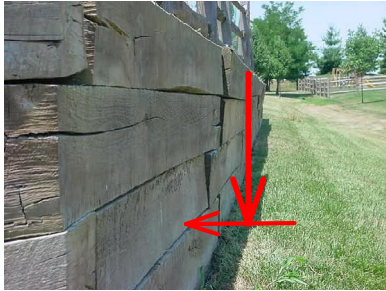
1. Vegetation: Shrubs with some weeds
2. Retaining Walls: Railroad ties / The wall is showing signs of movement, but appears to be stable at this time. A qualified contractor is recommended to evaluate and estimate repairs to maintain the wall.

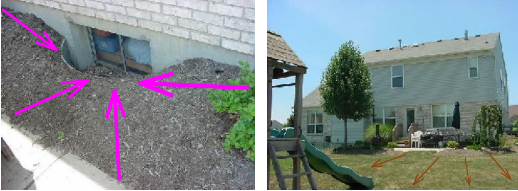
1. **Deck:** Treated wood / The deck has been built below acceptable building standards and is not safe in its current state. Recommend further evaluation and estimate to bring deck up to an acceptable building standard.
2. **Grading:** Moderate slope / The grade and landscaping materials are too high and extend above the window well at the Northeast rear of the home. Recommend that the grade be reduced or the metal window well soil retainer be replaced with a taller unit to keep the mulch and soil beds from washing into the well.

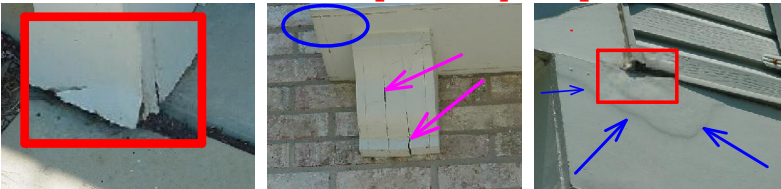
4. **Trim:** Composite material / Note: Damaged wood areas should be checked while doing the repair and replaced if wood rot is present.

1. Water damage to trim wood at either side of garage door from moisture wicking into the finished particle board. The surface is starting to delaminate. Recommend repair/replacement of the trim boards and silicone seal wood that is in contact with concrete to prevent wicking.

2. The wood window boxes have water damage and will require repair/replacement. The wood has started to separate at the supports and at the corners of the window boxes.

3. The trim board at the southwest corner of the porch has water damage due to water penetration and will require repair/replacement of the wood. The trim board extends out creating a ledge allowing water to collect on the top edge of the board and cause the wood to rot.

Recommend estimate/repairs by a qualified contractor.
